# ANALYSIS OF THE IMPACT OF WATER QUALITY DECLINE AND TERRESTRIAL BIOTA DISTURBANCE DUE TO GALENA ORE MINING ACTIVITIES: A CASE STUDY OF PT CHRISTINA EXPLO MINING

Amran<sup>1</sup>, Alwi Sibali<sup>2</sup>

<sup>1</sup> Mining Engineering Study Program, Faculty of Engineering, Universitas Bosowa Makassar  
<sup>2</sup> Polimarin AMI Makassar

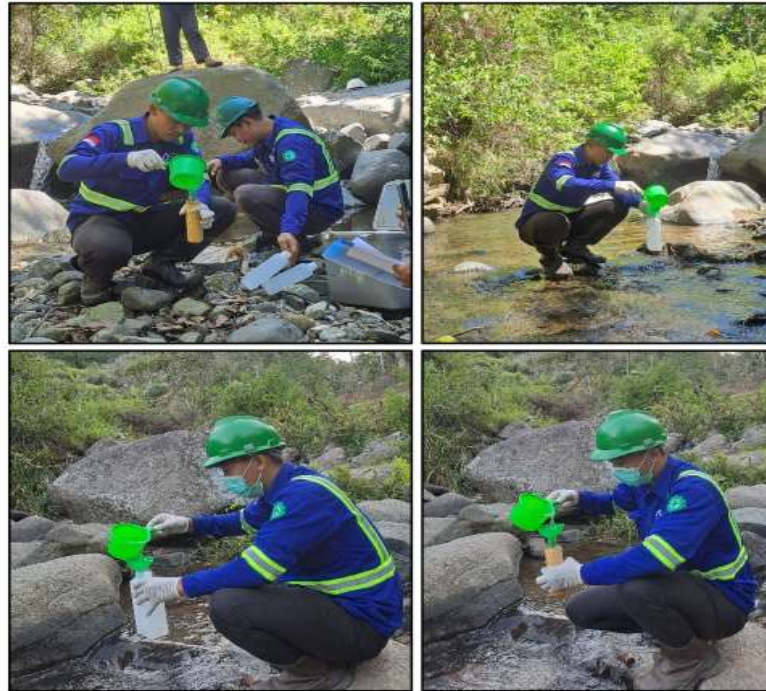
**Figure 1: Documentation of Sasak River Water Sampling**

The research was conducted in the mining area of PT Christina Explo Mining during the first quarter of 2024, covering the Sasak River and Rero River as the main sampling locations.

- **Water Quality:** Water sampling was carried out using the grab sampling method according to SNI 6989.59:2008, including physical parameters (TSS, TDS, turbidity), chemical (pH, nitrate, nitrite, ammonia, heavy metals), and microbiological (E. coli, Total Coliform).
- **Terrestrial Biota:** Direct observations were made to identify changes in local flora and fauna using key species study approaches and visual documentation.

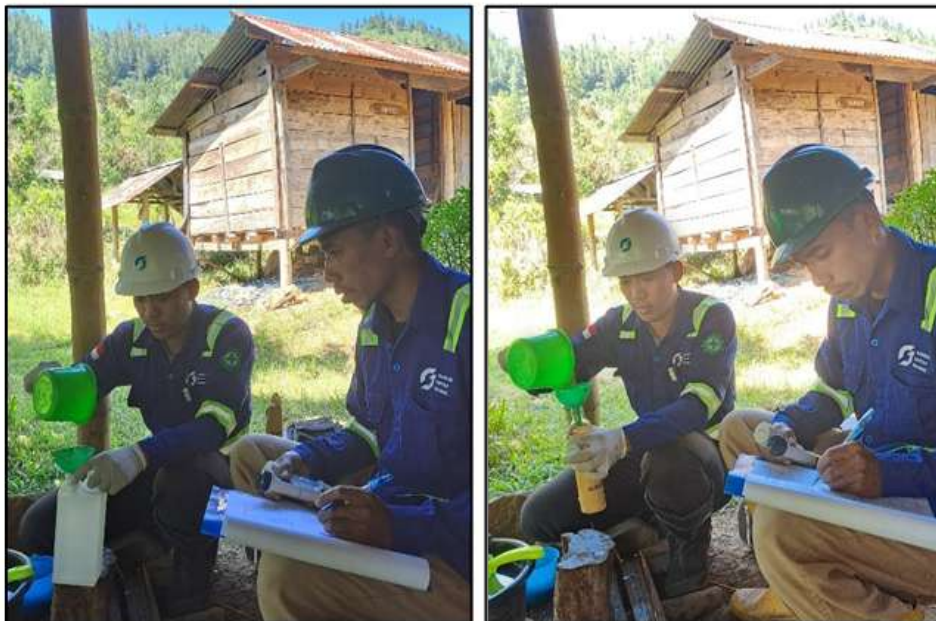
**2: Clean Water Conditions at Camp and Analysis Location**

TDS = 146 mg/L, turbidity = 0.05 NTU, and odorless. Although E. coli was not detected, Total Coliform = 51 CFU/100 mL, exceeding the quality standard of 0 CFU/100 mL, indicating the need for attention to drinking water sanitation.
